ANGKOR VAT

INDIA'S CONTRIBUTION IN CONSERVATION

MEMOIRS OF THE
ARCHAEOLOGICAL SURVEY OF INDIA
NO. 91

B. NARASIMHAIAH

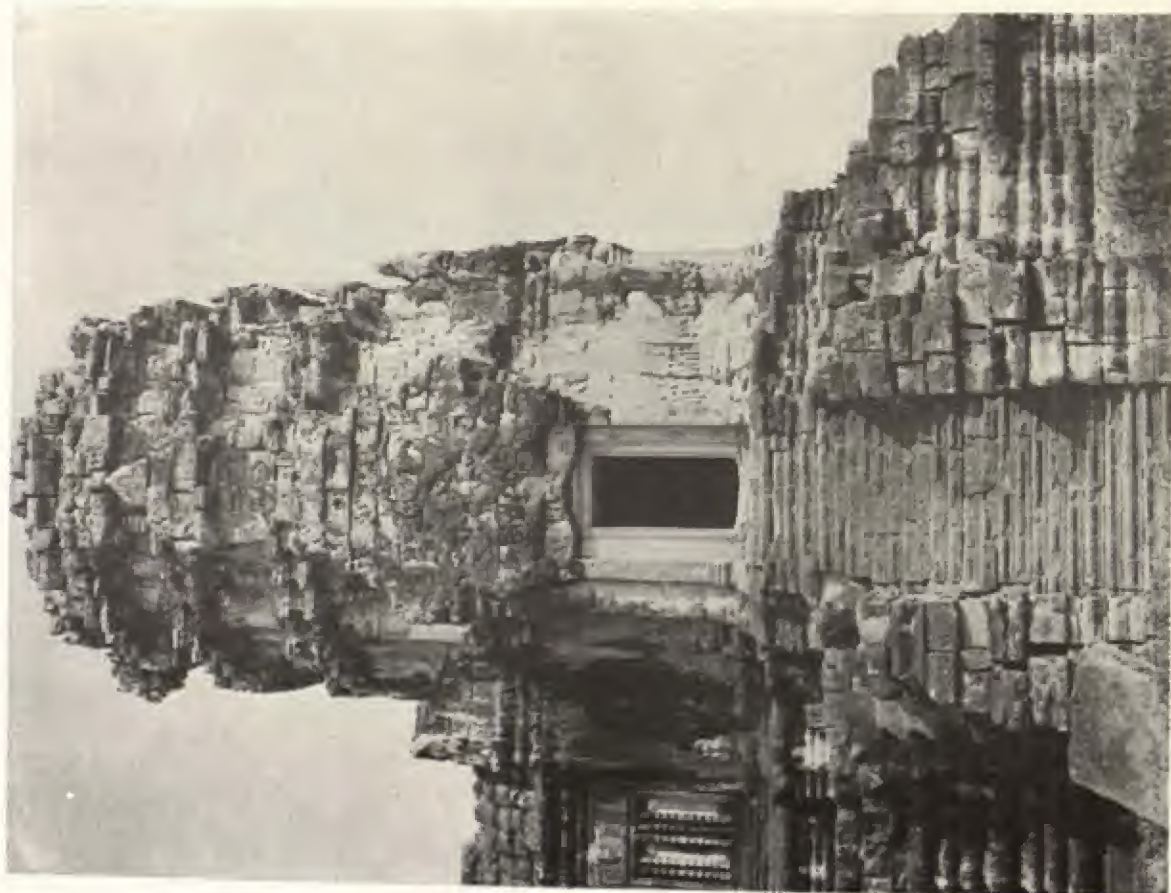
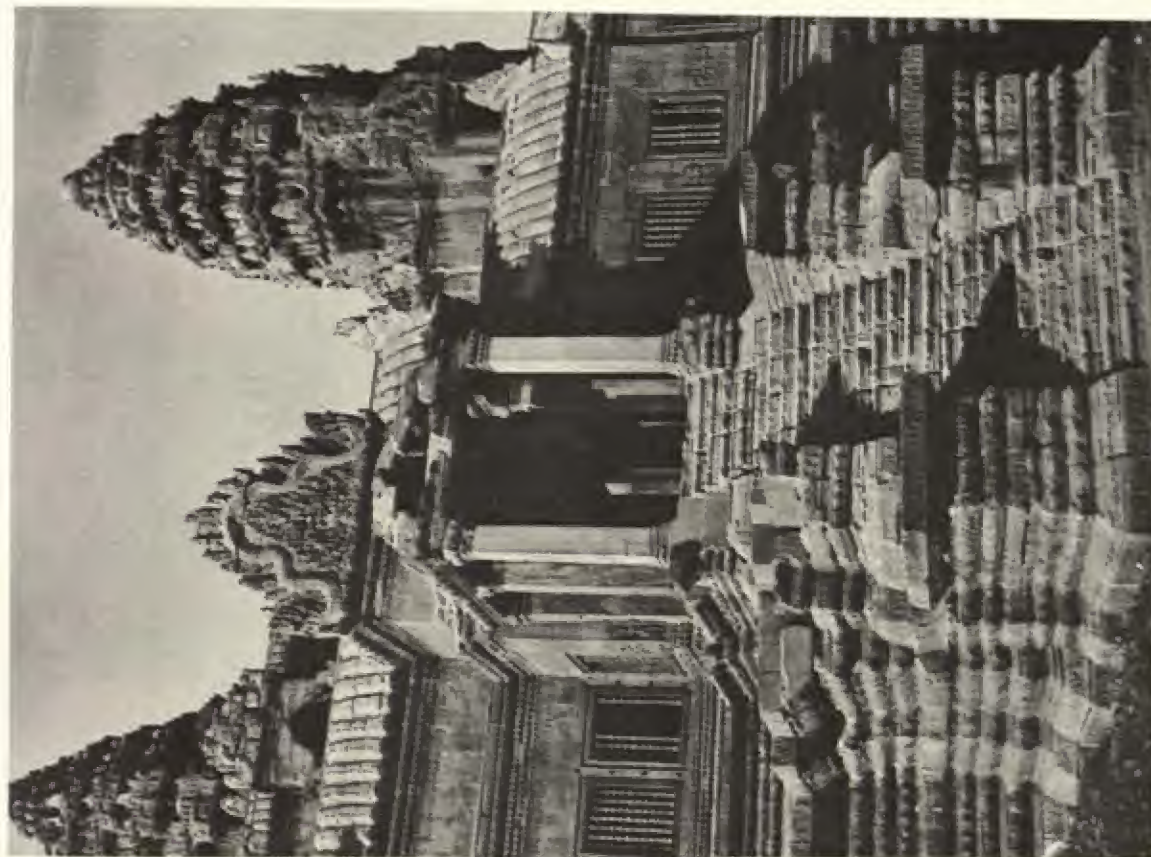
Second Enclosure ; southern entrance at east corner. A, before and B, after conservation

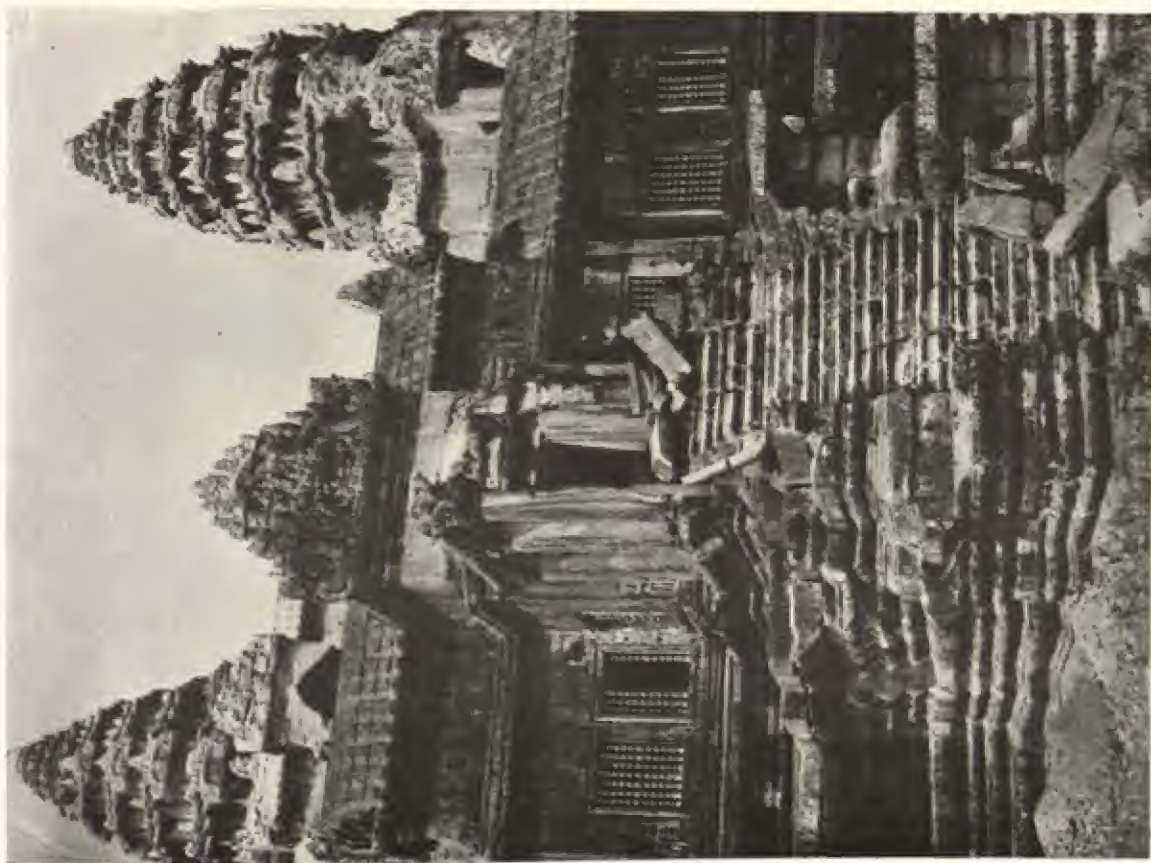
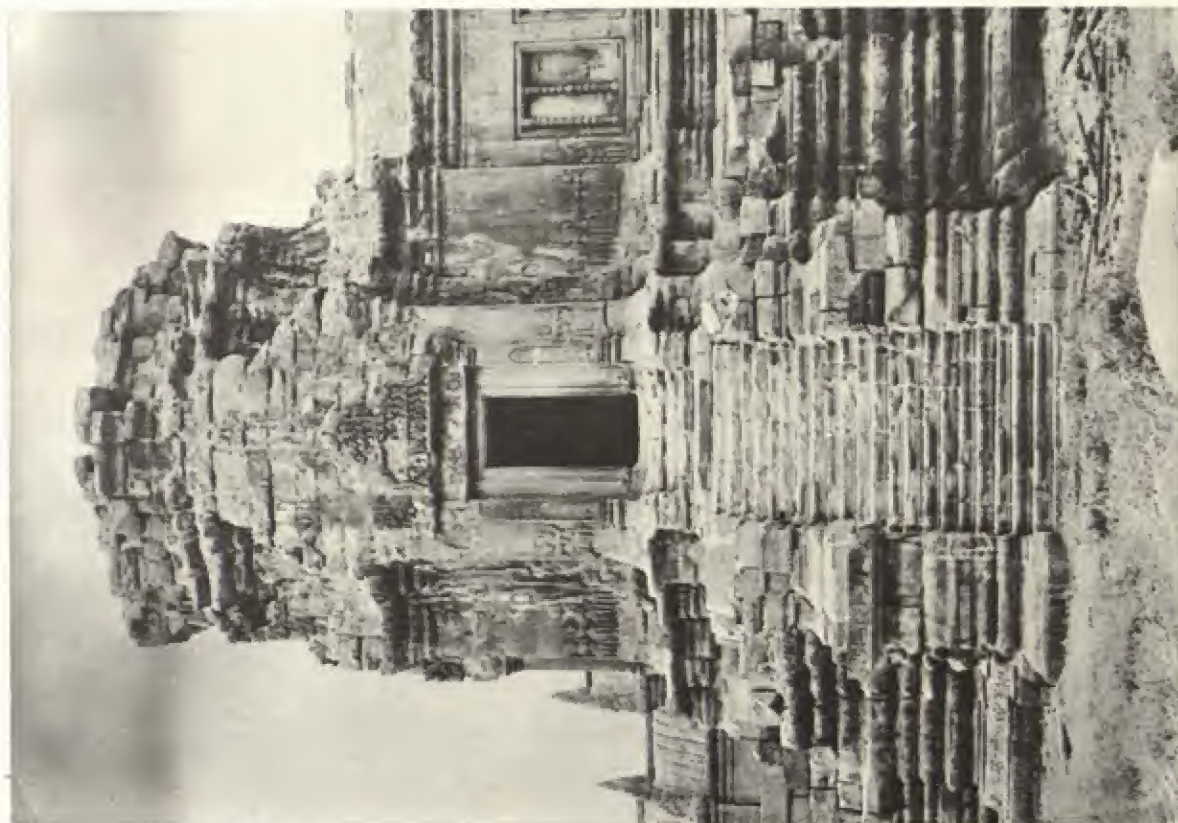
Second Enclosure : southern central entrance. A, before and B, after conservation

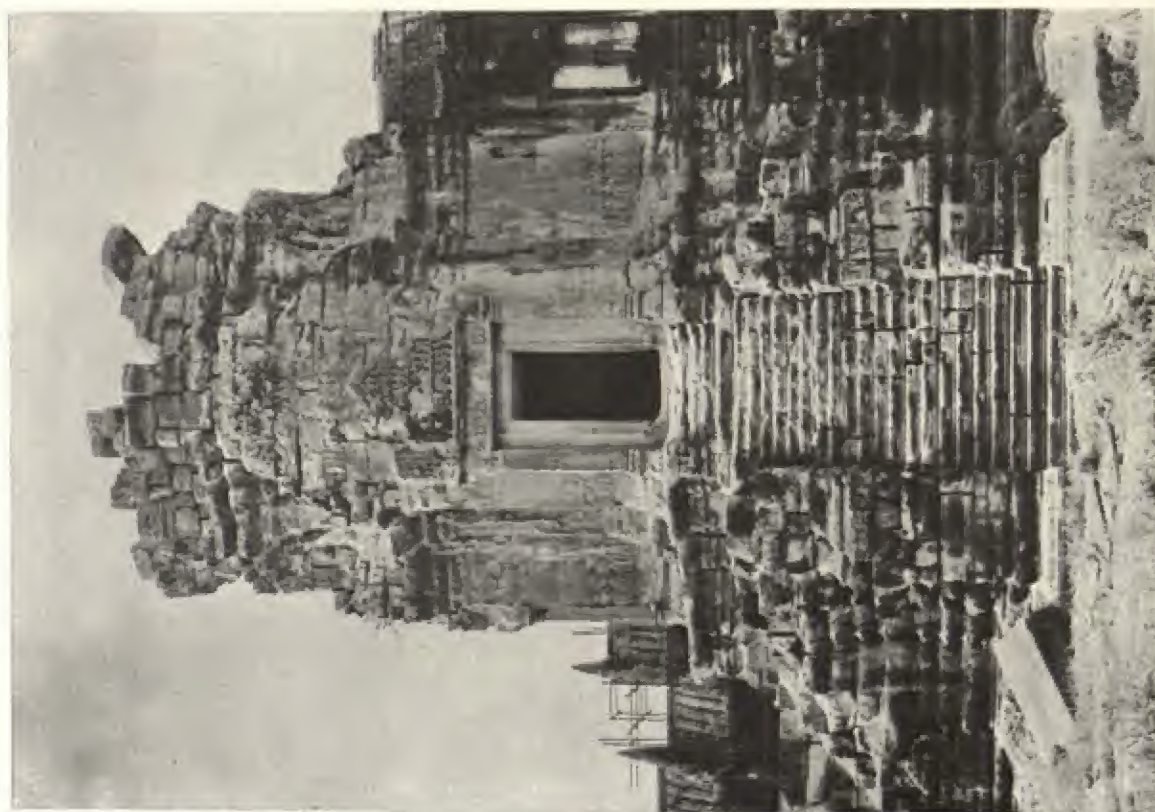
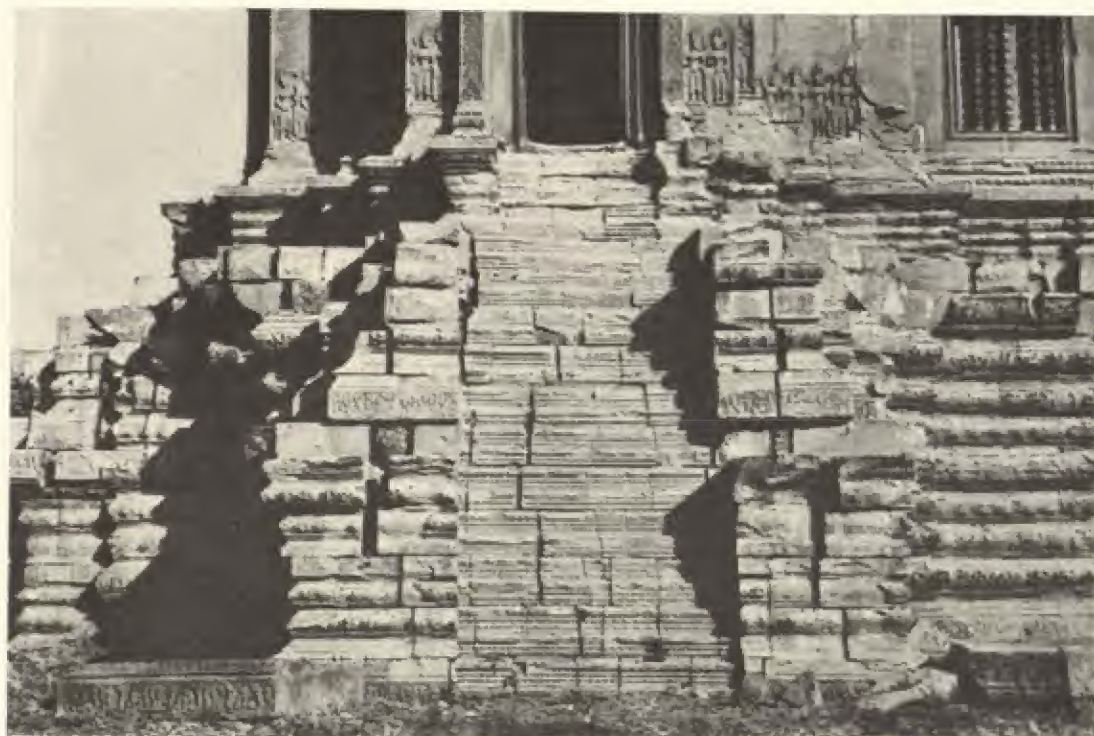
Second Enclosure : southern entrance at west corner, A, before and B, after conservation

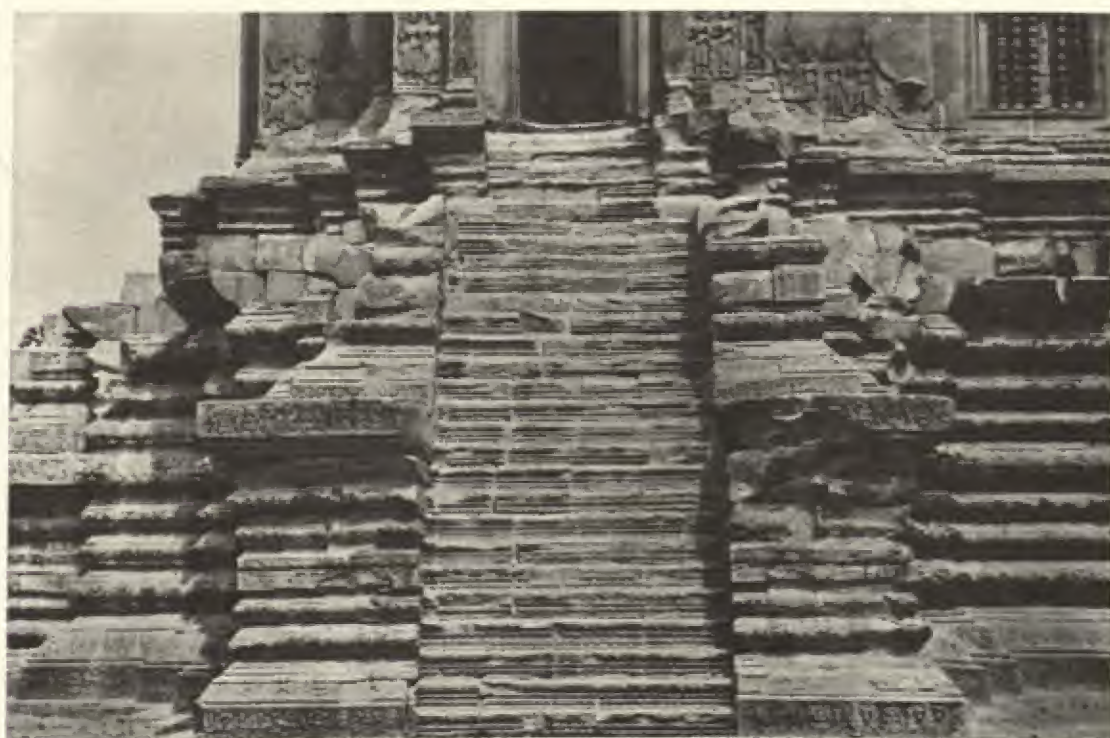
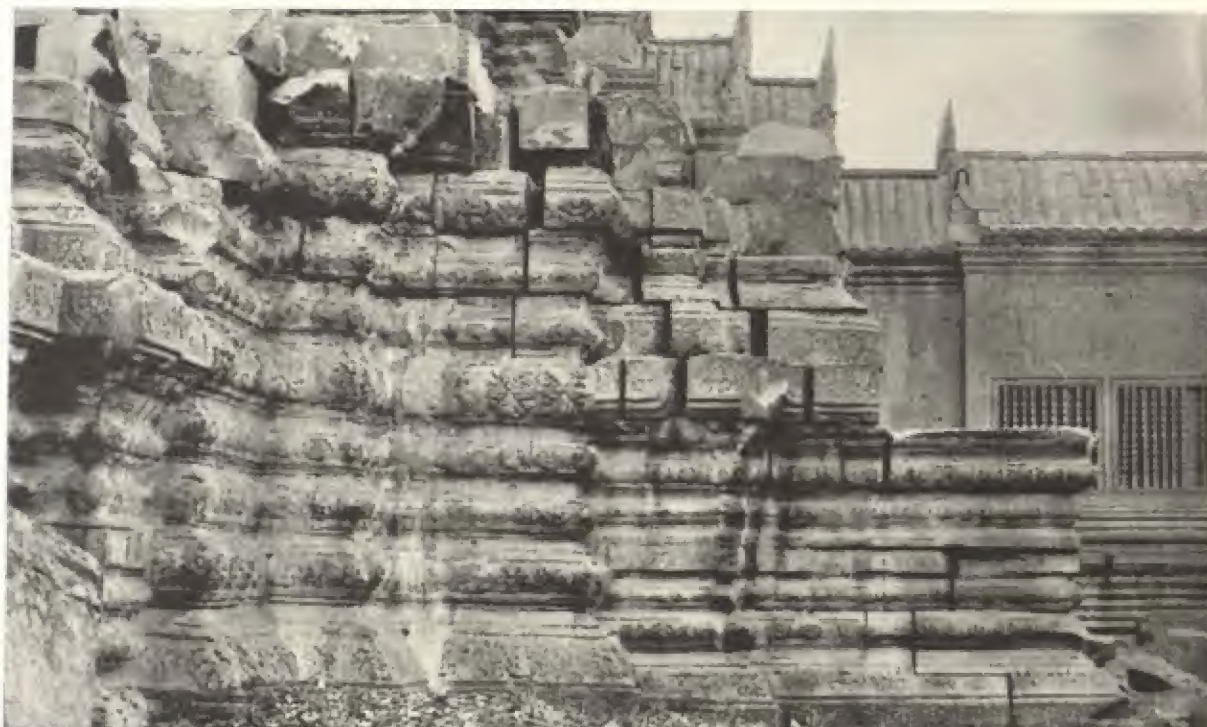
Second Enclosure : western entrance at south corner. A, before and B, after conservation

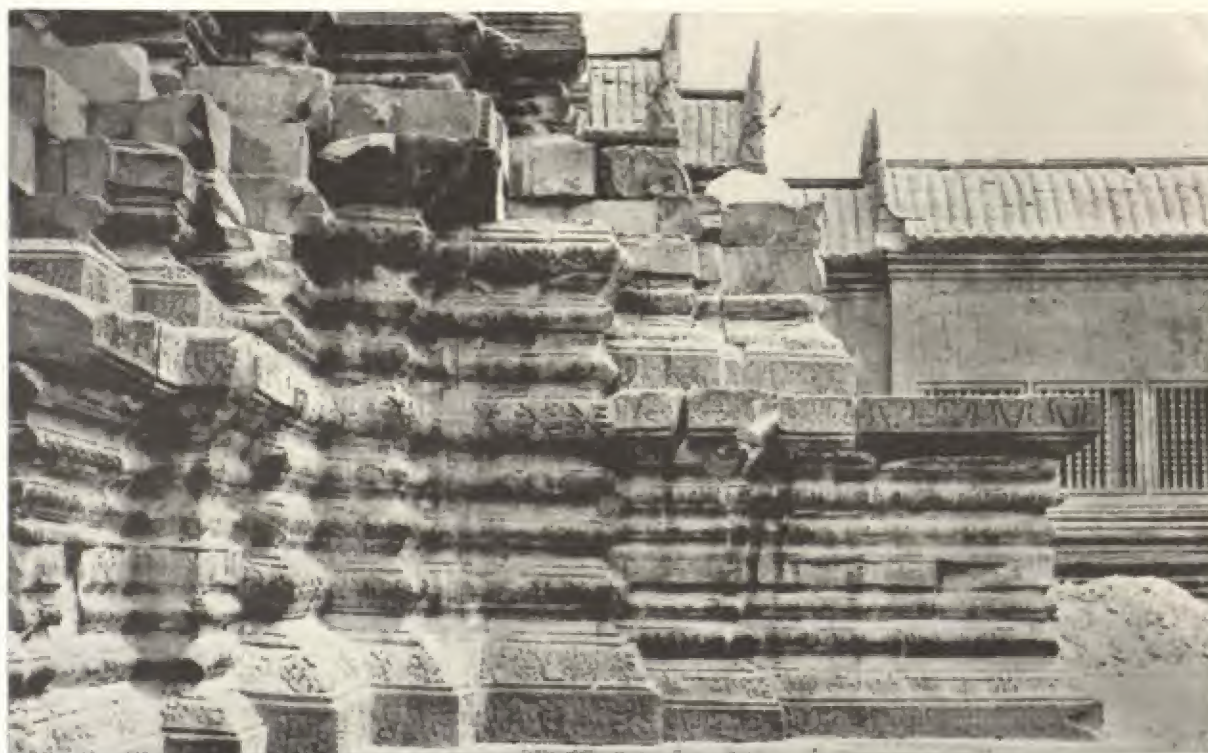
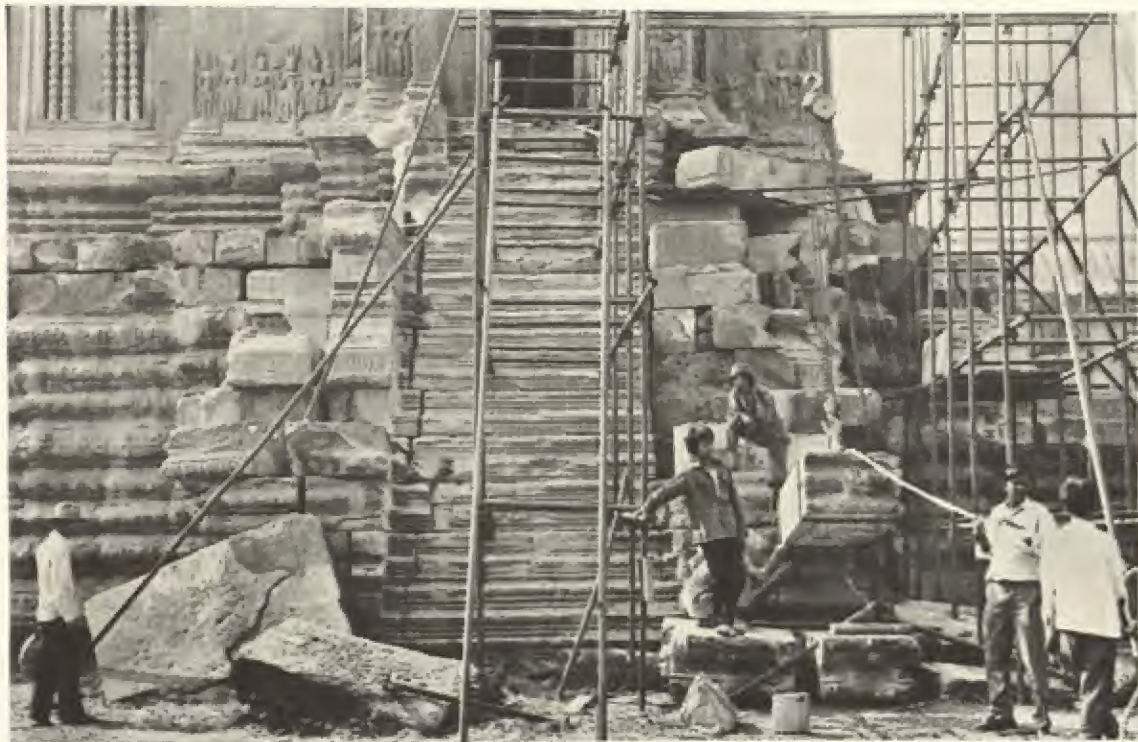
Second Enclosure : western entrance at north corner, A, before and B, after conservation

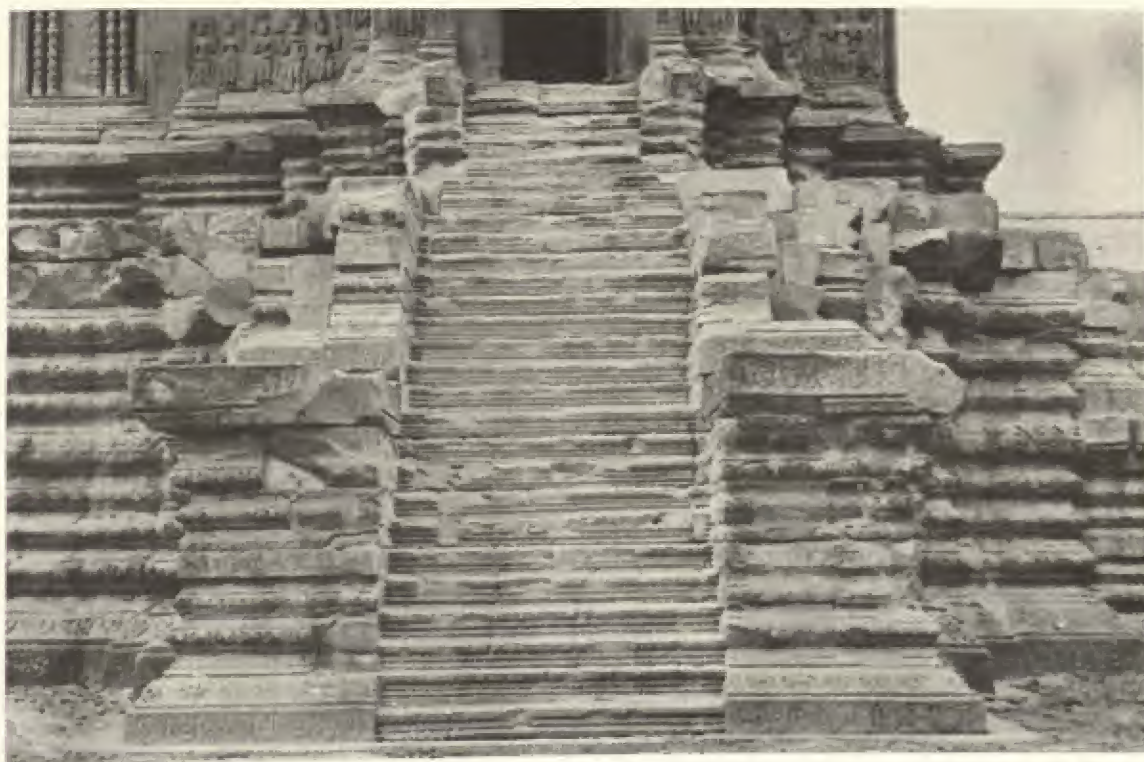
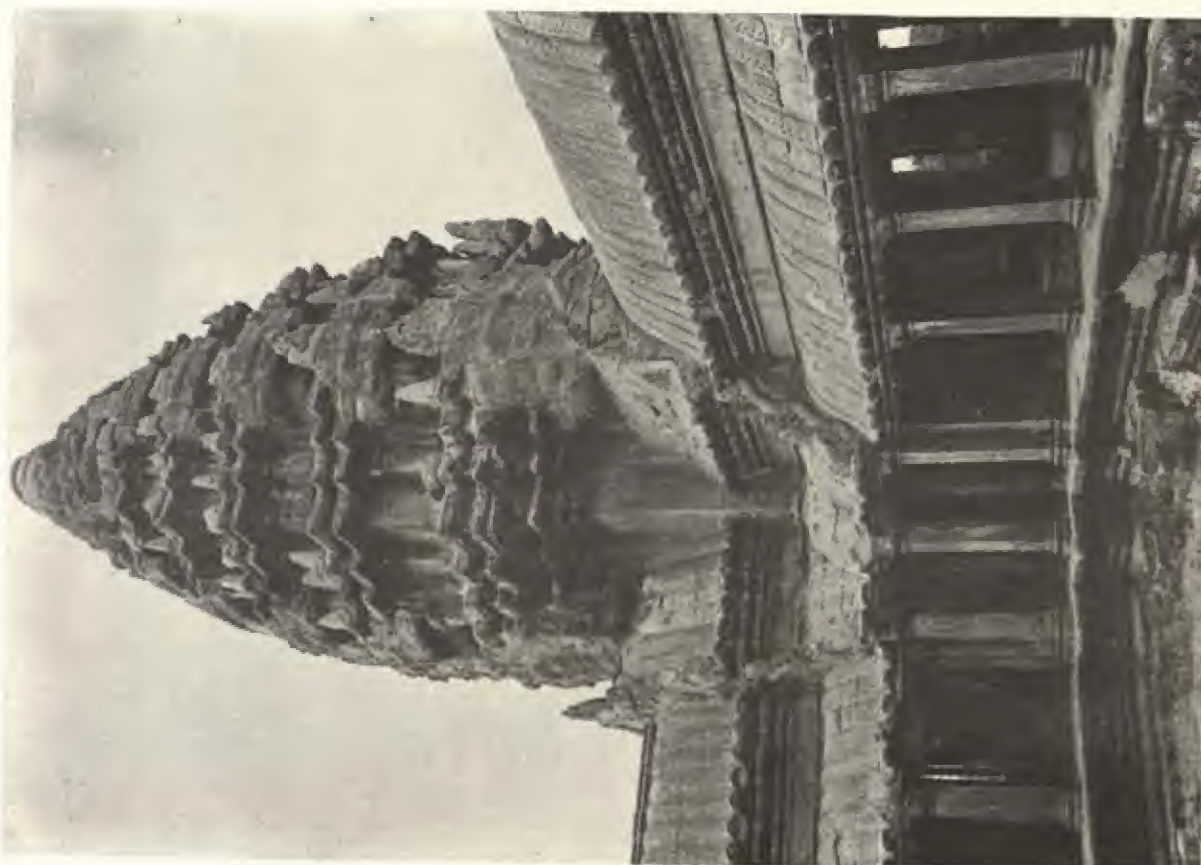
Second Enclosure : northern entrance at west corner, A, before and B, after conservation

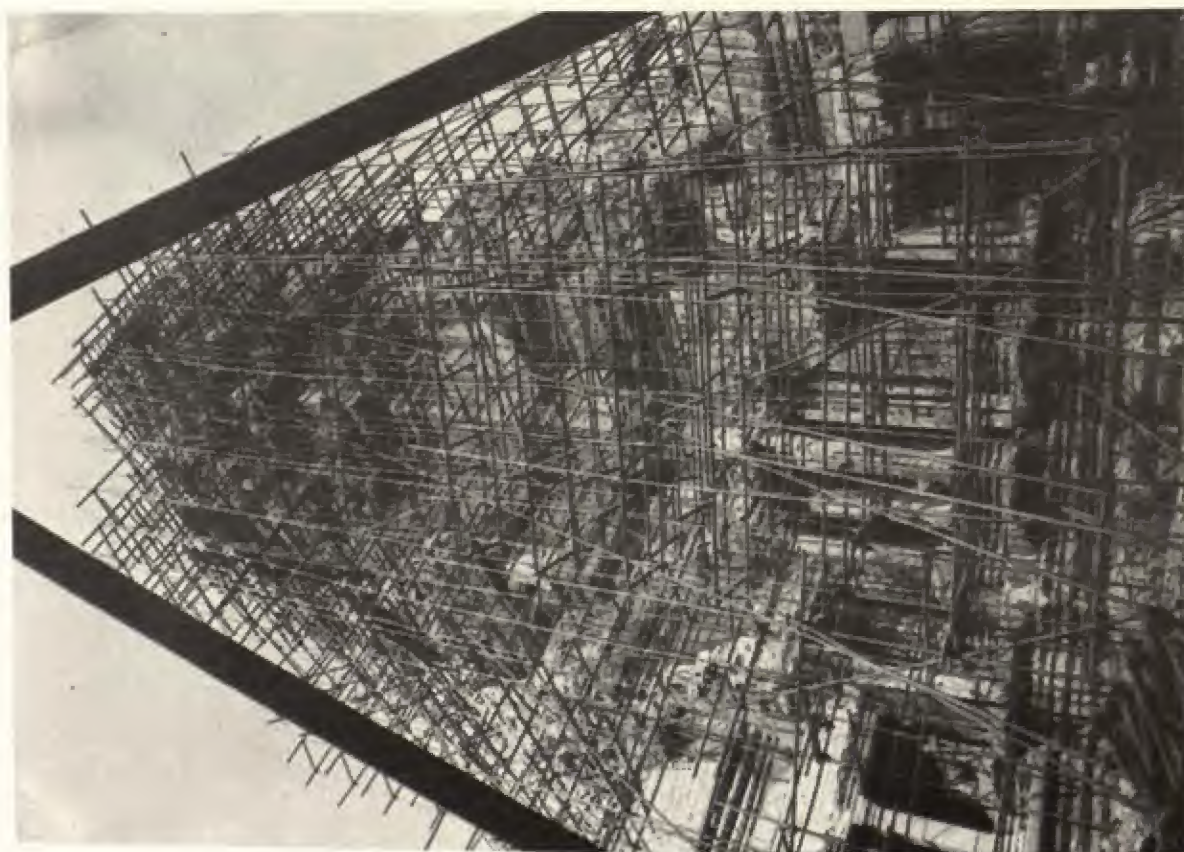
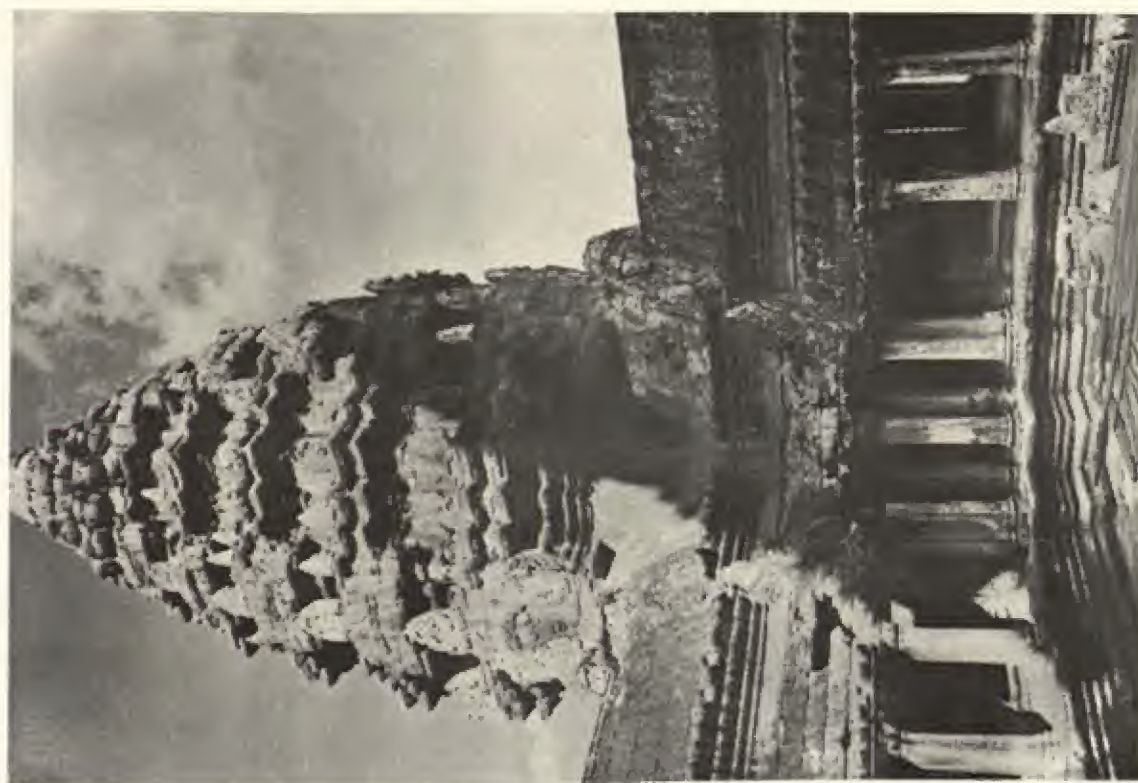
First Enclosure : central tower, A, during and B, after conservation and chemical treatment

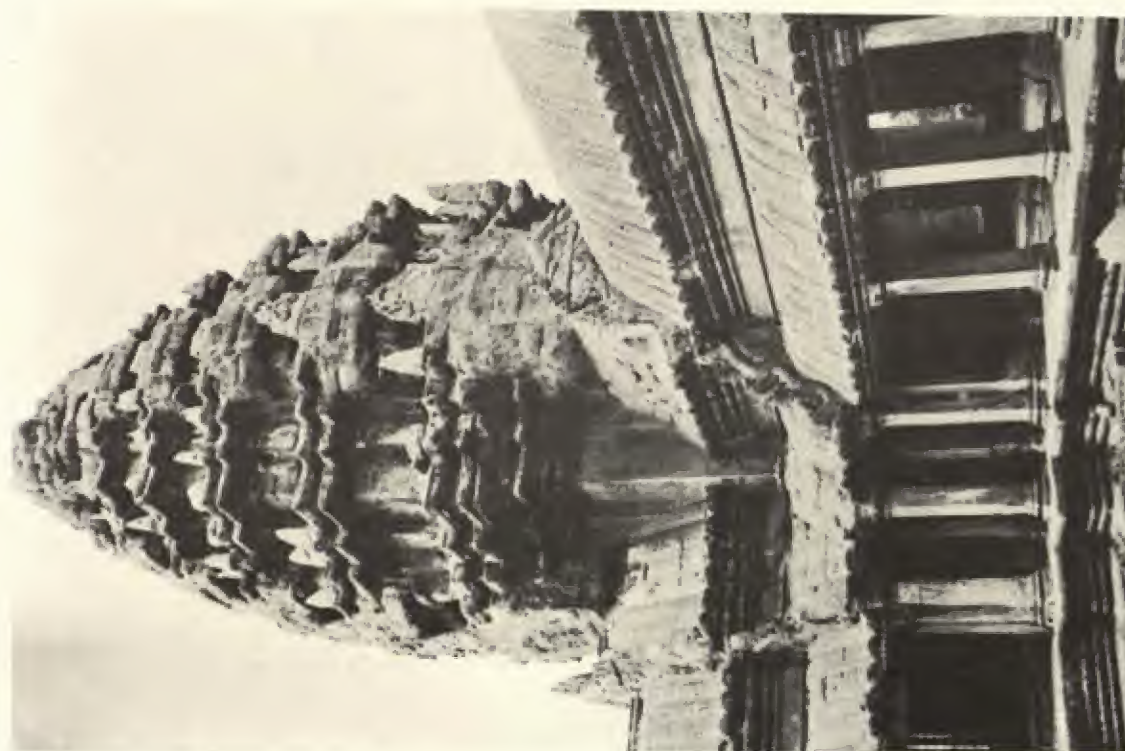
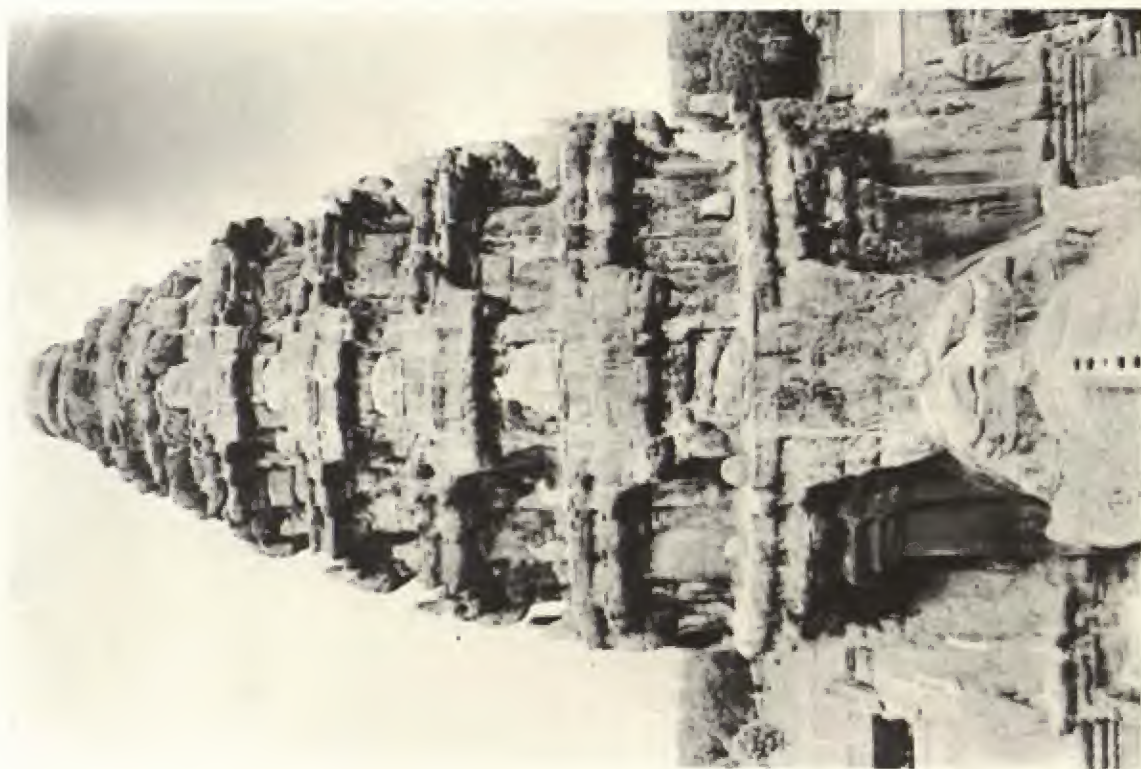
First Enclosure : north-east tower, A, before and B, after conservation and chemical treatment

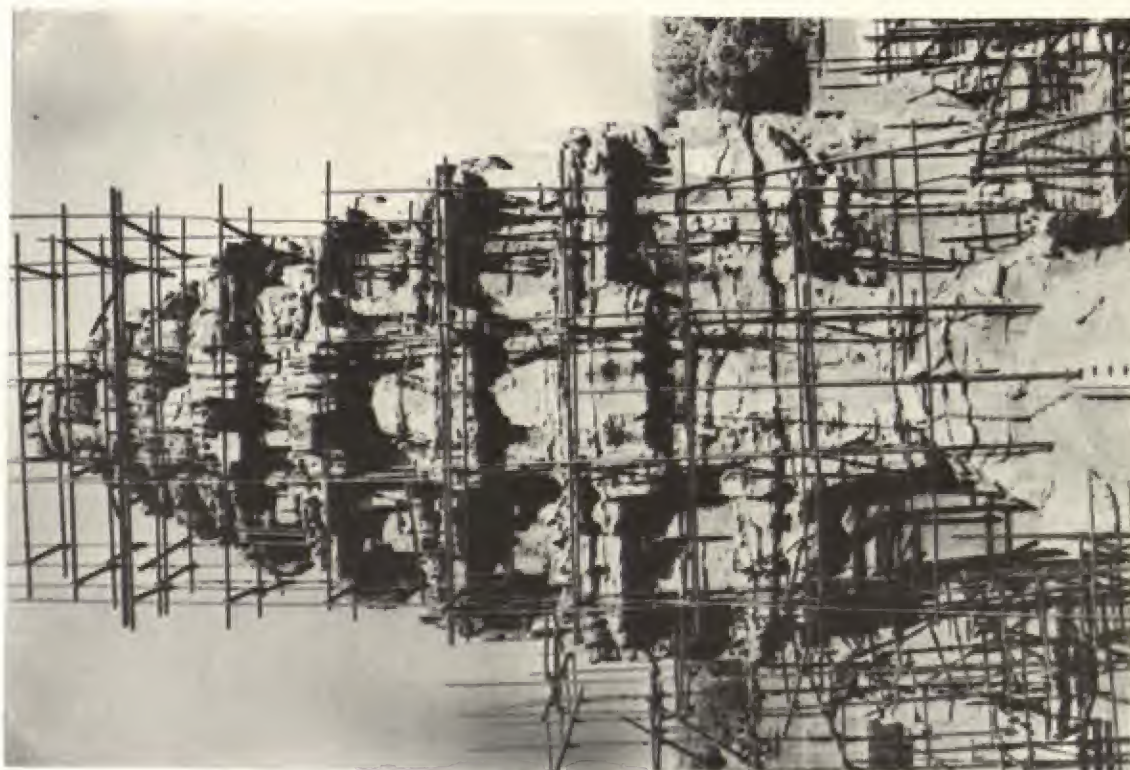
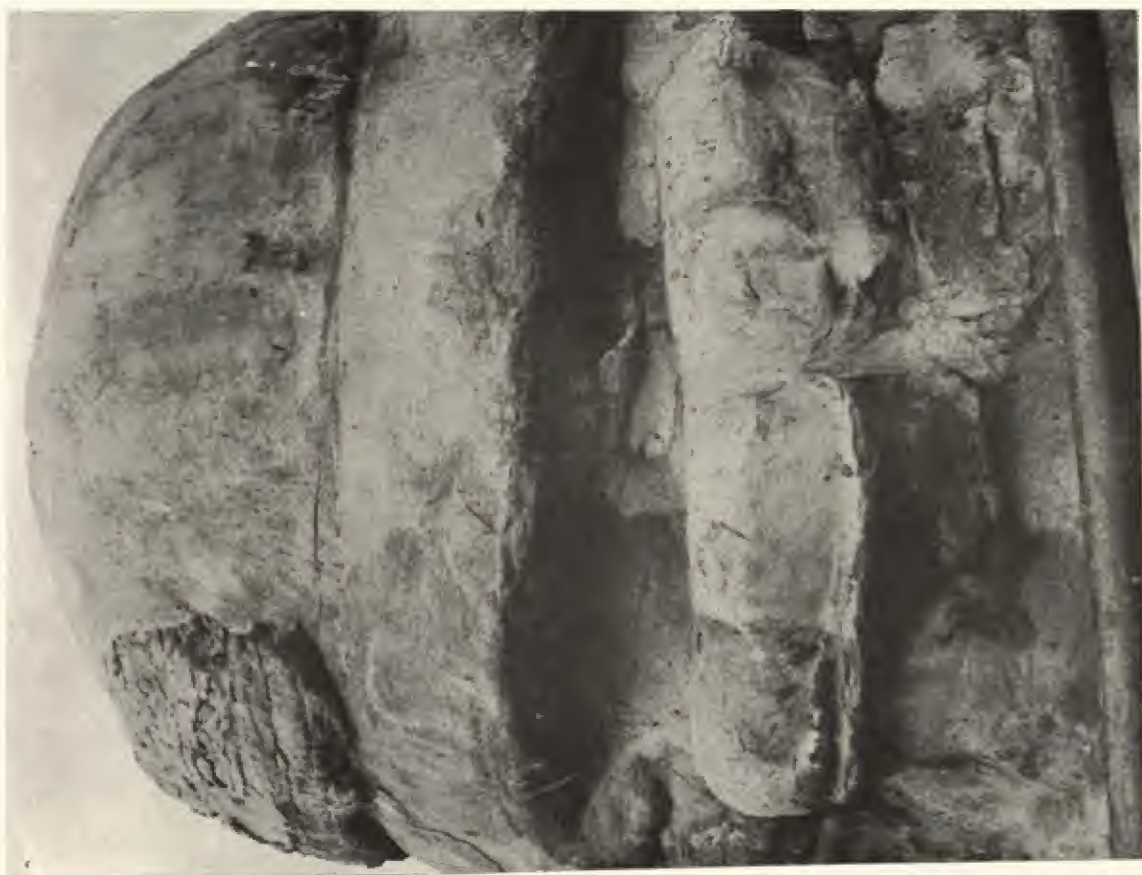
First Enclosure : north-west corner tower, A, during and B, after conservation

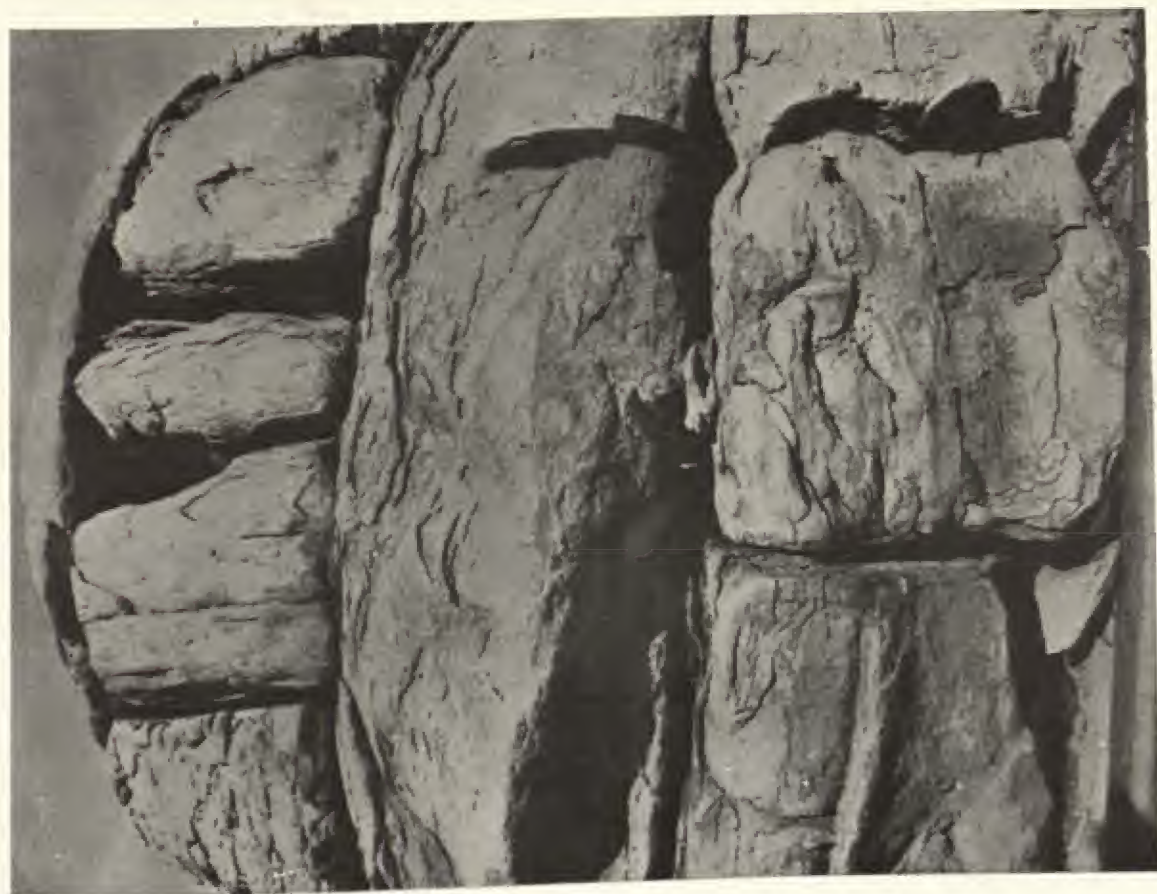
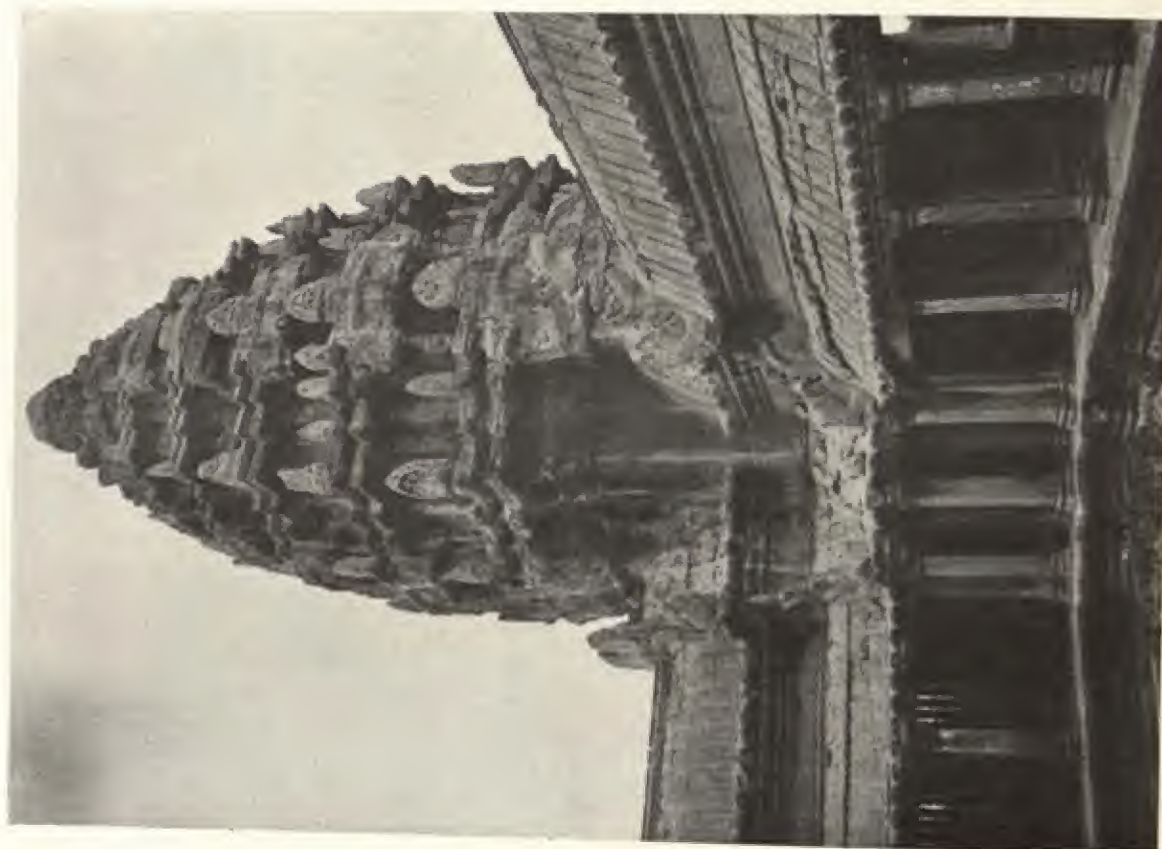
First Enclosure : north-west corner tower, A, before and B, after conservation and chemical treatment

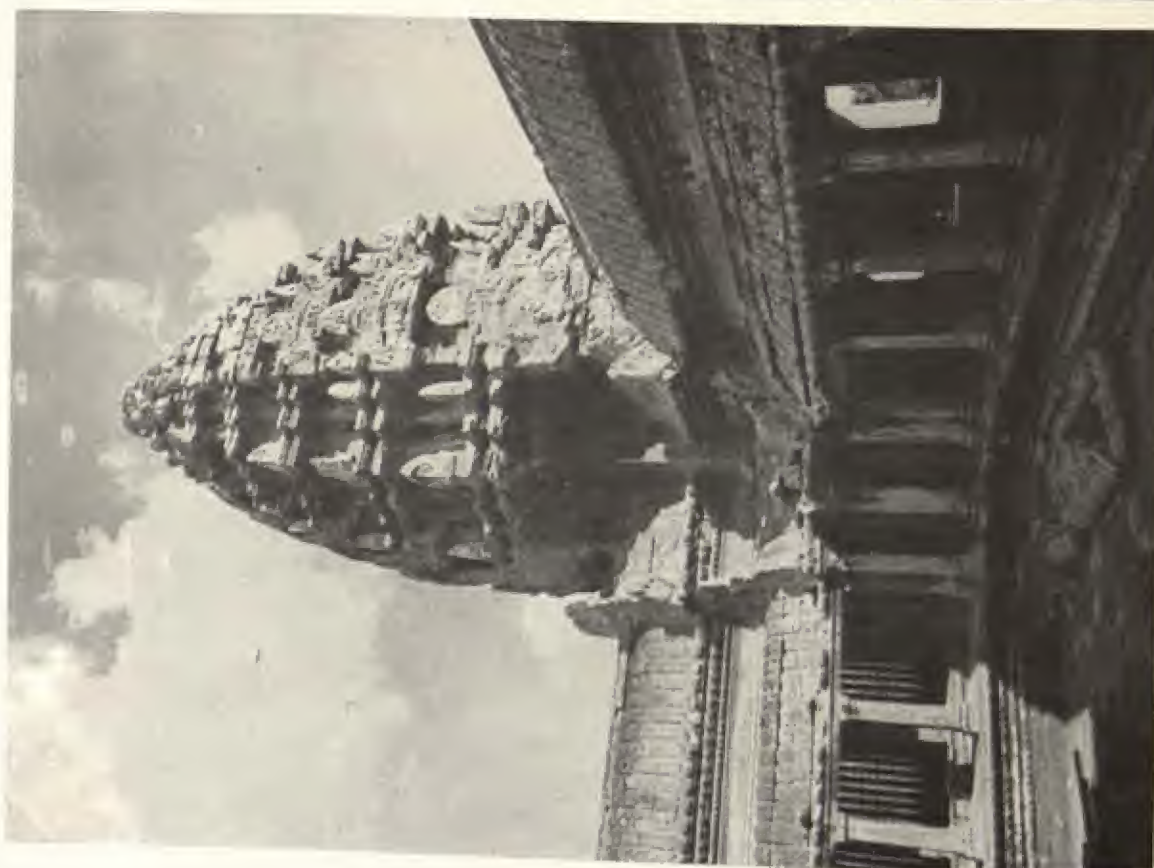
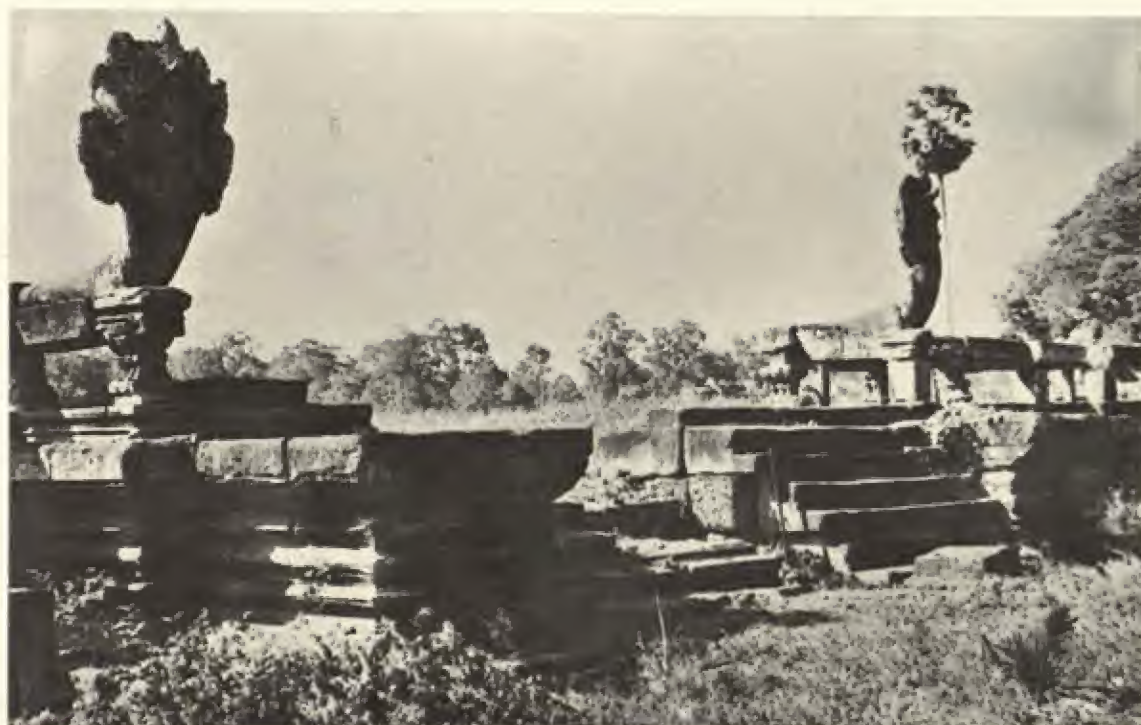
First Enclosure : south-west corner tower, A, before and B, after conservation

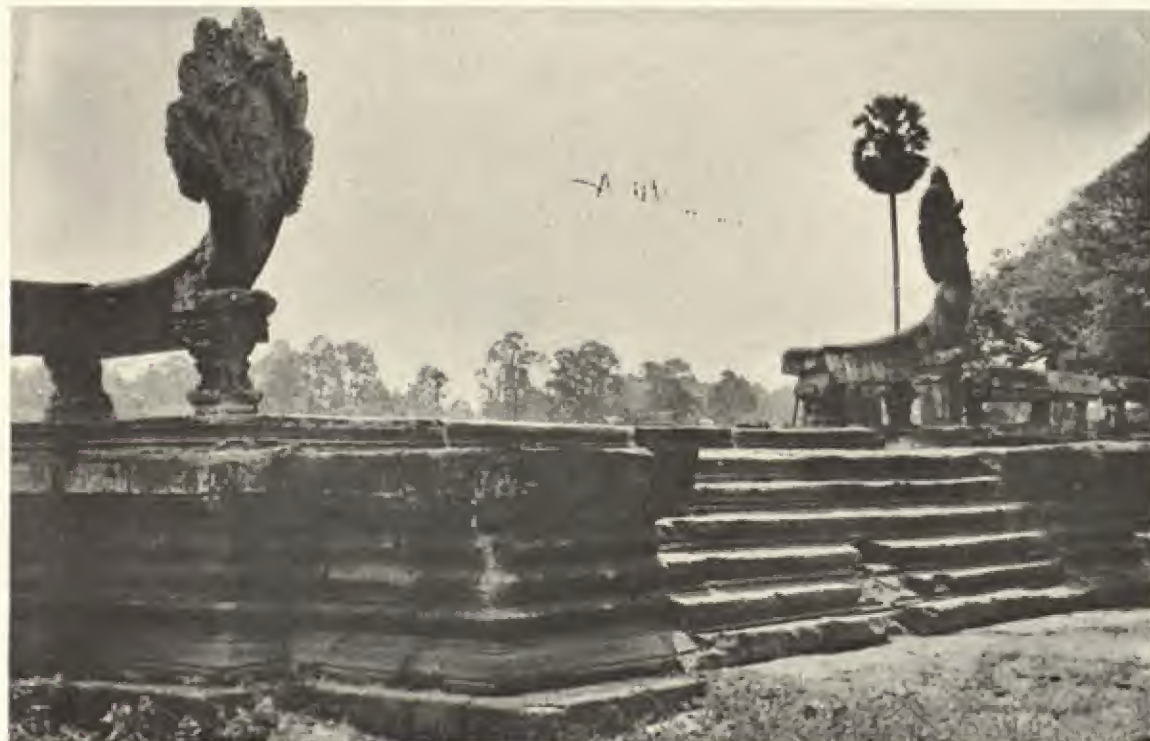
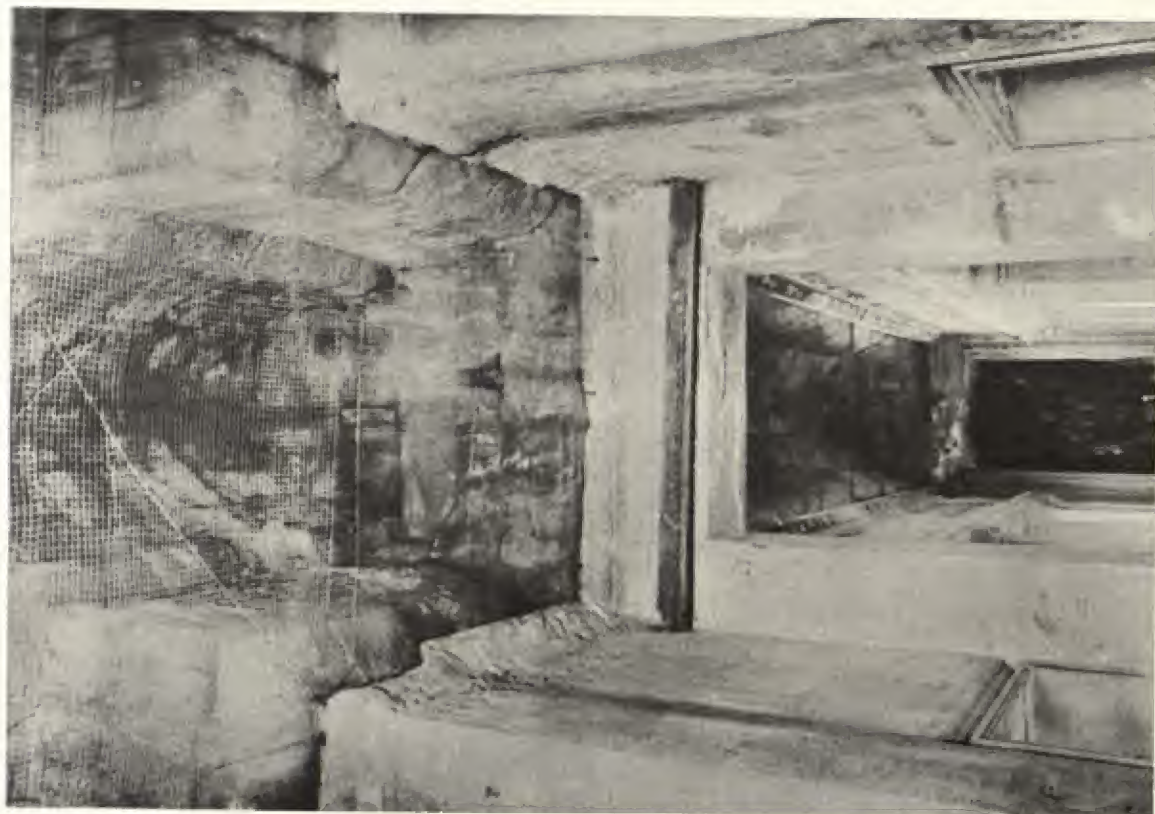
Railing between Third and Fourth Enclosures : stepped entrance at north-west corner, A, before and B, after conservation
